Urgent Field Safety Notice
Immediate Action Required – Product Recall
iPAD CU-SP1 / CU-SP1 Auto defibrillators

Some CU-SP1, CU-SP1 AUTO defibrillators overstate the battery status as 'full' even when the battery energy condition is 'low'.

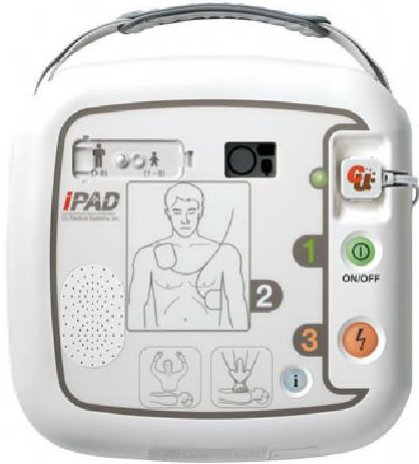
<p>Model Number: CU-SP1</p> </div> <div style="text-align: center;">

Information on Affected Devices					
1	<p>1. Device Types and Models</p> <p>The CU-SP1 series is semi-automated external defibrillators (AED) and the CU-SP1 AUTO is a fully automated external defibrillator (AED). If connected to a patient, it automatically acquires and analyses the electrocardiogram (ECG) of the patient for the presence of Ventricular Fibrillation or Ventricular Tachycardia (also known as shockable rhythms).</p> <div style="display: flex; justify-content: space-around; align-items: center;"> <div style="text-align: center;">

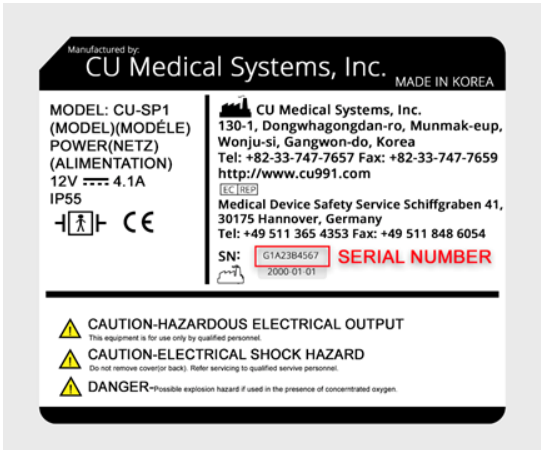
3.	<p>1. Action To Be Taken by the User</p> <p style="display: flex; justify-content: space-between;"> <input checked="" type="checkbox"/> Identify Device <input checked="" type="checkbox"/> Return Device </p> <p><input checked="" type="checkbox"/> On-site device modification/inspection</p> <p>Step 1 – Identify defibrillators Model CU-SP1 and CU-SP1 Auto.</p> <p>The model number, the date of manufacture and the serial number are presented on the label on rear of unit.</p> <div style="text-align: center;">

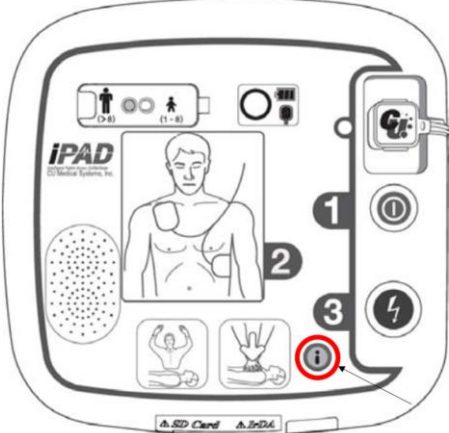
</div> <p>Step 2 – Interrogate the unit to identify the software version installed is V1.41 or earlier for CU-SP1 and V1.10 or earlier for CU-SP1 AUTO by following these steps:</p> <p style="margin-left: 40px;">One. Press i-button for 2 seconds to confirm the software version.</p> <div style="text-align: center;">

</div> <p style="margin-left: 40px;">Two. The first 3 digits of 9 digits are the software version. For instance, if the device utters <u>1 4 0</u> 1 0 0 1 0 0, <u>V1.40</u> is the software version.</p> <p>Step 3 – If you are in the UK, please visit the website to arrange software update. http://www.ipad-aed.com/softwareupgrade</p> <p>If you are in Hungary or Ukraine, please contact Manufacturer’s Branch – CU Medical Germany GmbH, to arrange software update.</p>
